Case Vehicle (A): 1999 Saturn

Type: SL2, 4-door sedan Driver: 46-year-old female CDC: 01-FDEW-1, 03-RBLE-1

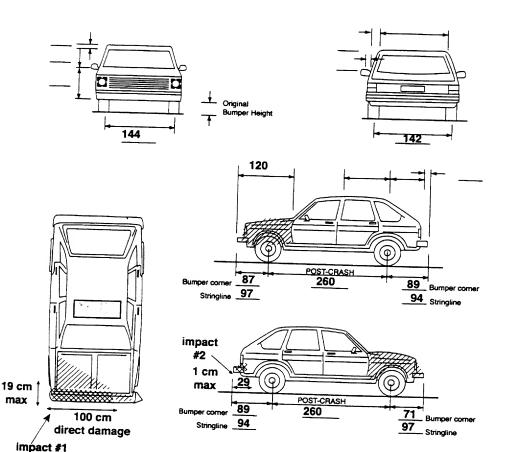
VEHICLE DAMAGE

(Slide 3) The first impact to the front of case vehicle (A) was minor. The direct damage began at the right-front bumper corner and extended 100 cm across the front bumper, resulting in 72-percent vehicle overlap. The maximum crush was 19 cm to the right-front bumper corner. The second impact to the right-rear bumper corner was very minor and resulted in scratches that extended 29 cm along the right side of the bumper cover.

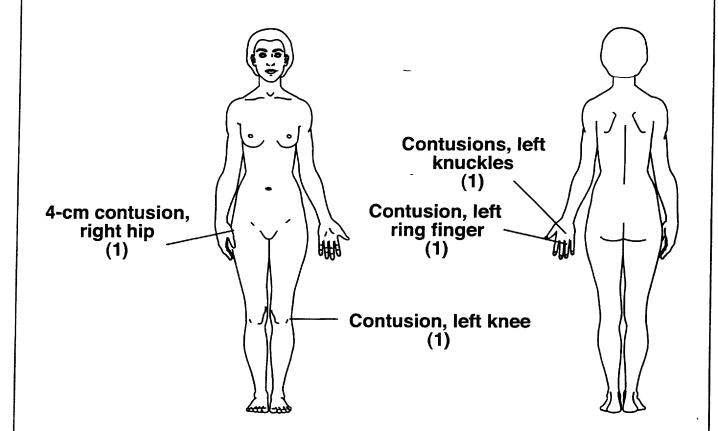
INDICATE LOCATION OF INJURIES.

The following table and attached drawing (slide 45) summarize the injuries for the restrained driver.

| | | | Injury Source | | |
|---|---|---|---|---|--|
| Contusion, left ring finger | 1 | | Roof siderail (airbag fling) | | |
| Contusions, left knuckles | 1 | | Roof siderail (airbag fling) | | |
| 4-cm contusion, right hip | 1 | | Seatbelt buckle assembly | Center console/armrest | |
| Contusion, left knee | 1 | | Knee bolster | | |
